**Key words:** RW reservoir, iron, manganese, dissolved oxygen, short-circuiting, chemical savings

**Reservoir or Lake Use:** Man-made lined storage reservoir which receives water from a local lake. This reservoir serves as a raw water source for a city.

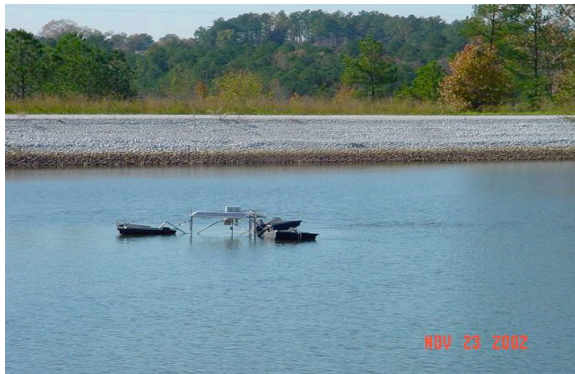
**Photos:** Top photo shows one of two SolarBees in the plant's pretreatment reservoir; second photo shows placement of both units in the reservoir.

**SolarBee Installation:** Date: November 2002; installed two (2) SB10000 units with 24-hour kits; a chemical injection kit was also installed on one SolarBee.
