Key words: RW reservoir, taste and odor, blue-green algae

Reservoir or Lake Use: Reservoir # 2 is a raw water storage reservoir for the city, and was built for additional storage for drinking water.

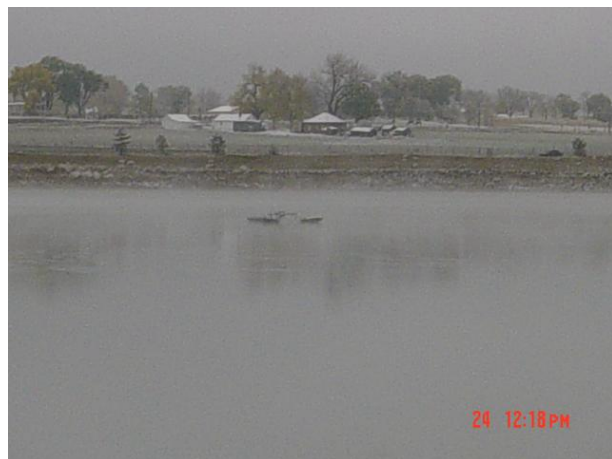
Photos: Shows one unit in the reservoir; aerial photo shows reservoir shape and location of initial SolarBee installation.

SolarBee Installation: Date: October 2002, installed one (1) SB10000F, solar-powered, with intake hose set at 23'. February 2004, installed a second SB10000F in the reservoir.
