Key words: recreational lake, blue-green algae, odors, impaired fishery, aquatic weeds, dissolved oxygen, clarity, stagnation, fountain

System Overview and Reservoir Data: Lake # 2 is part of a 4-lake chain, totaling 68 acres. Lake #2 has a surface area of 4 acres; maximum depth is 12 ft, minimum depth is 8 ft, average depth is 10 ft; volume is 41 acre-feet. Apple Finger is 2.1 acres off of Lake #4, and Joe's Finger is 1.3 acres off of Lake #1.

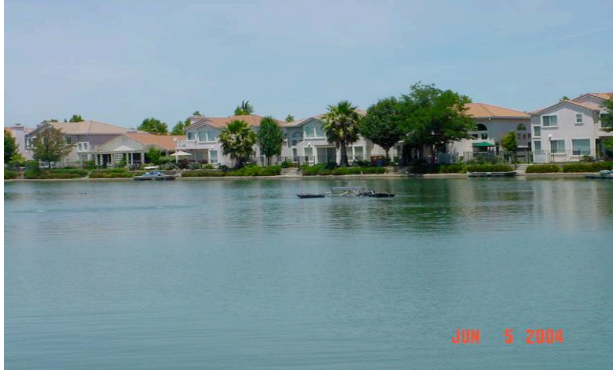
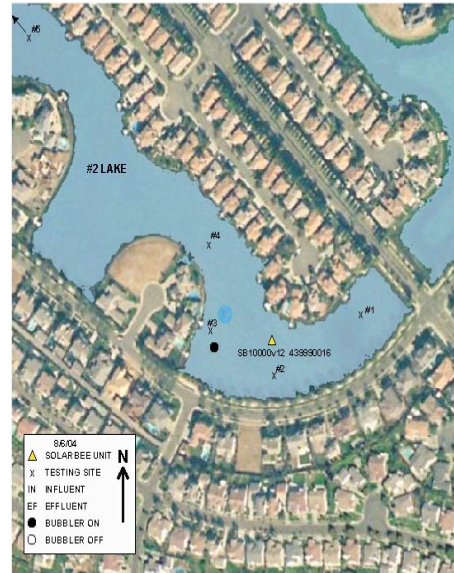
Photos: SB10000V12 in Lake #2 surrounded by densely populated housing; photo on right is an aerial shot showing SolarBee placement in the lake within the housing development.

SolarBee Installation: Date: June 5, 2004. Installed one solar-powered SB10000V12. The SolarBee was set in 10 ft of water with the intake tube set at 8 ft.
